**Test Report No. 221409988-02**  
**Dated 13 Jul 2016**

**SUBJECT**

Alkali Test

Product Name : Autotriz 3d Matrix Coating  
Part Number : V-1  
Country of Origin : Germany  
Sample Condition : The samples are received in good condition, no scratch or damage was observed.

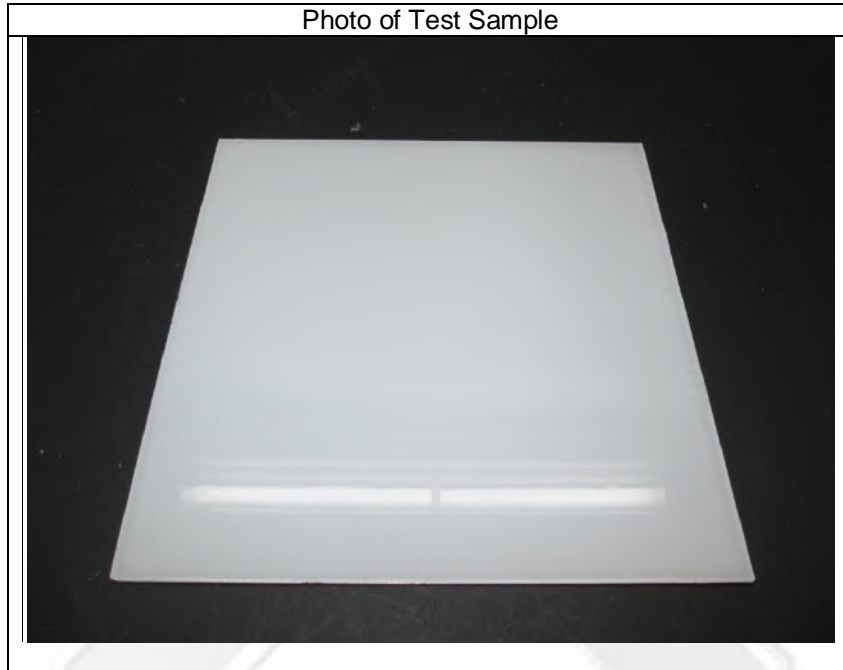
**PICTURE OF TEST SAMPLE**

Sample	Evaluation	Judgment
1	No severe defect found by visual checking.	Reported
2	No severe defect found by visual checking.	Reported
3	No severe defect found by visual checking.	Reported

- I. Sample was tested according to test method JIS K 5400 Testing Methods for Paints.
- II. Test condition as below
  - Solution : 5% Na<sub>2</sub>CO<sub>3</sub>
  - Temperature : 23±2°C
  - Duration : 24 hours
