Test Report No. 221409988-03
Dated 13 Jul 2016

Acid Test

Product Name : Autotriz 3d Matrix Coating
Part Number : V-1
Country of Origin : Germany
Sample Condition : The samples are received in good condition, no scratch or damage was observed.

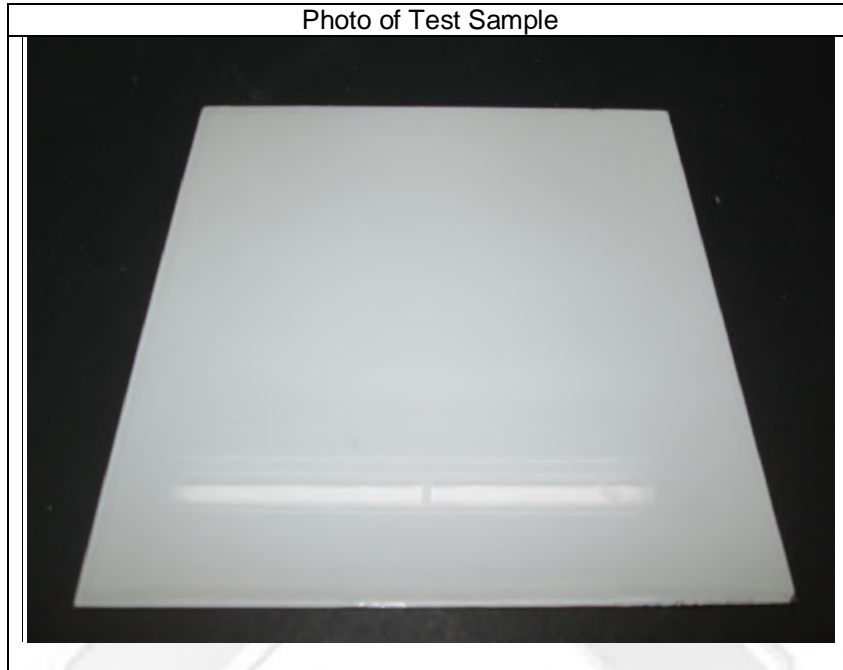
PICTURE OF TEST SAMPLE

Sample	Evaluation	Judgment
1	No severe defect found by visual checking.	Reported
2	No severe defect found by visual checking.	Reported
3	No severe defect found by visual checking.	Reported

- I. Sample was tested according to test method JIS K 5400 Testing Methods for Paints.
- II. Test condition as below
 - Solution : 5% H₂SO₄
 - Temperature : 23±2°C
 - Duration : 24 hours
